CONNECTICUT RIVER BASIN
BERLIN, CONNECTICUT

WASEL RESERVOIR DAM

CT. 00260

PHASE I INSPECTION REPORT
NATIONAL DAM INSPECTION PROGRAM

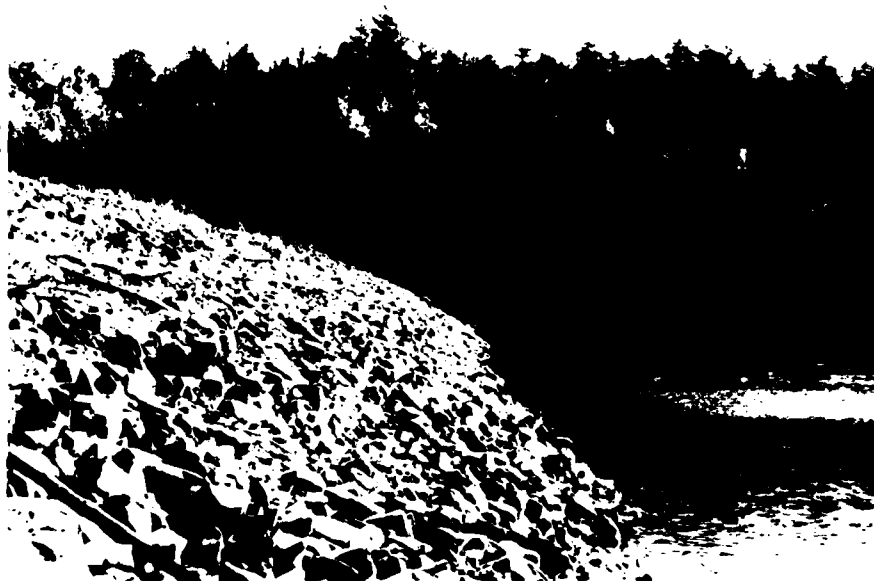
Overview from right abutment
